The
Leuchter
Reports

Critical Edition

Fred A. Leuchter, Jr.
Robert Faurisson
Germar Rudolf

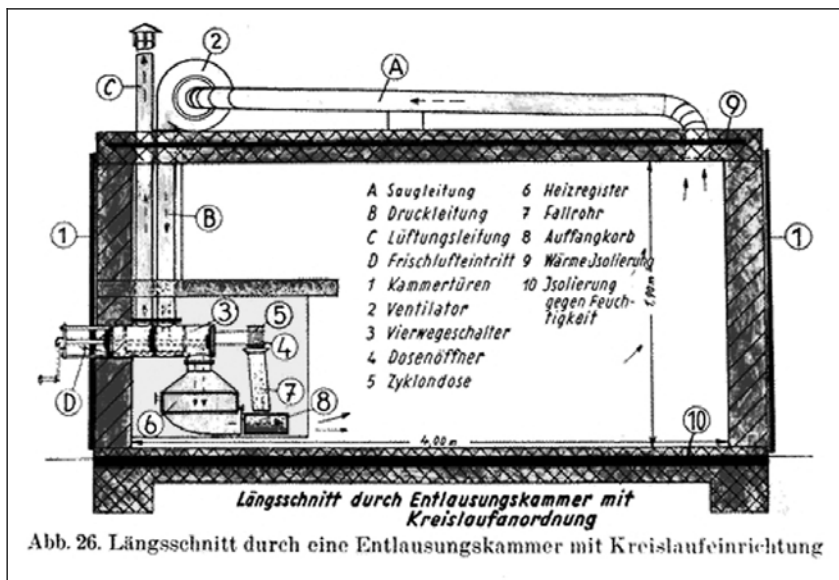
Fig. 3: DEGESCH delousing chamber with circulation feature.⁴¹ This design was developed in the late 1930s / early 1940s and became a standard in Germany during the war. It was, however, not installed in all concentration camps, which were frequently equipped with makeshift delousing chambers. Editor's note.

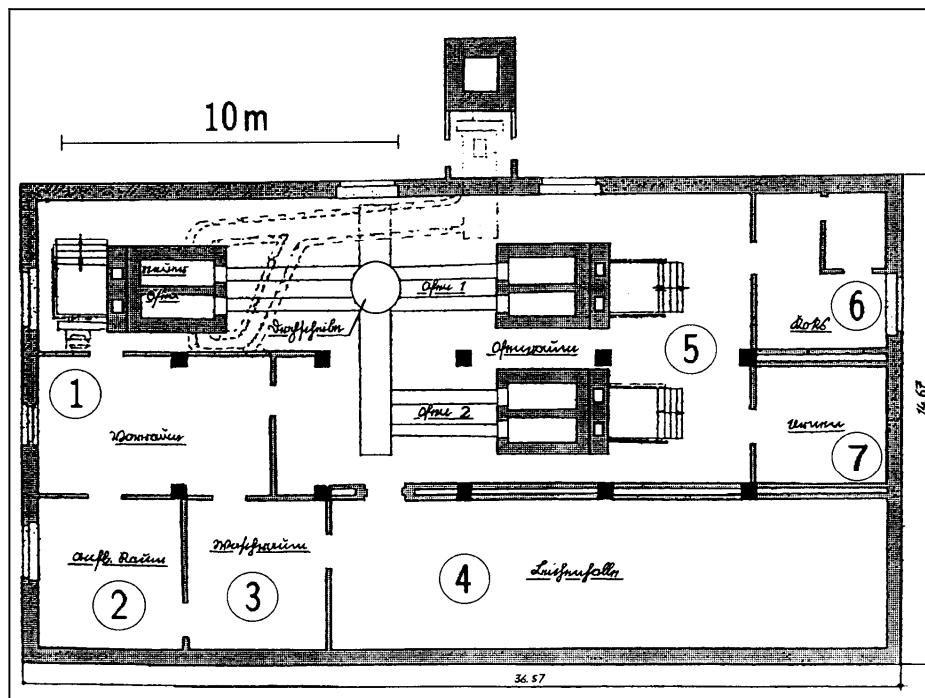
Fig. 4: Ground plan of crematorium I in Auschwitz I/main camp in its original condition. The morgue was later alleged to have been used as a 'gas chamber'.¹²⁵

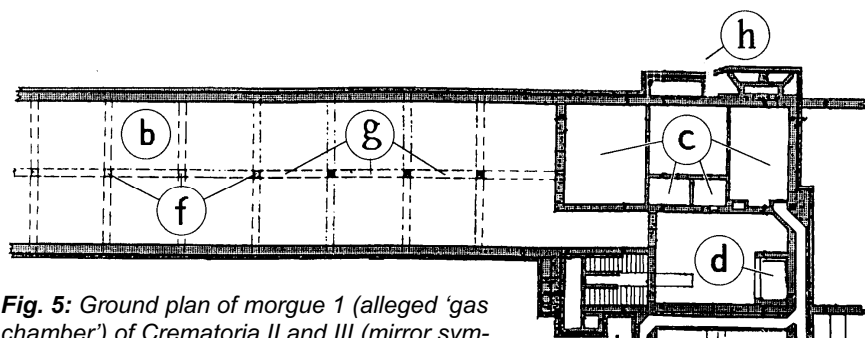
Fig. 5: Ground plan of morgue 1 (alleged 'gas chamber') of Crematoria II and III (mirror symmetrical) in Auschwitz II/ Birkenau camp.¹³⁷

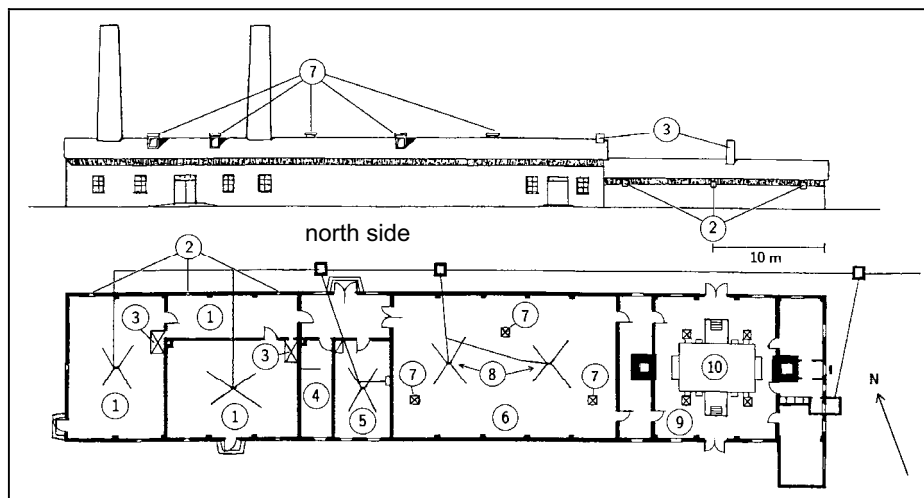
Fig. 7: North lateral view (above) and ground plan (below) of crematorium IV and/or V (mirror image) in Auschwitz II/Birkenau camp.¹⁴⁹

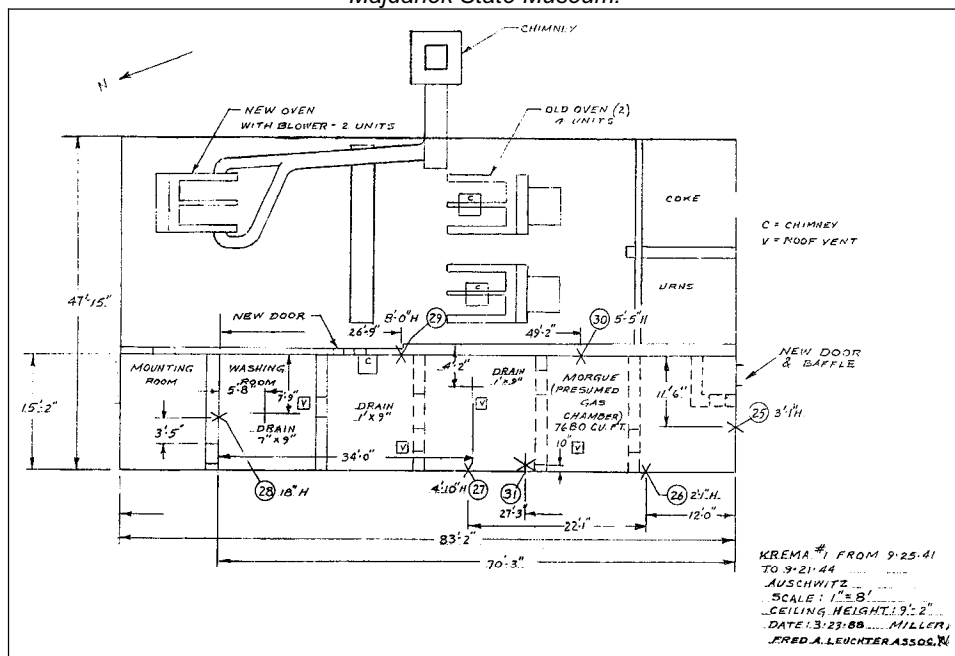
Fig. 12: Floor plan of Krematorium I in Auschwitz main camp, drawn by H. Miller, Fred A. Leuchter Associates. Numbers in circles denote locations where wall sample were taken.

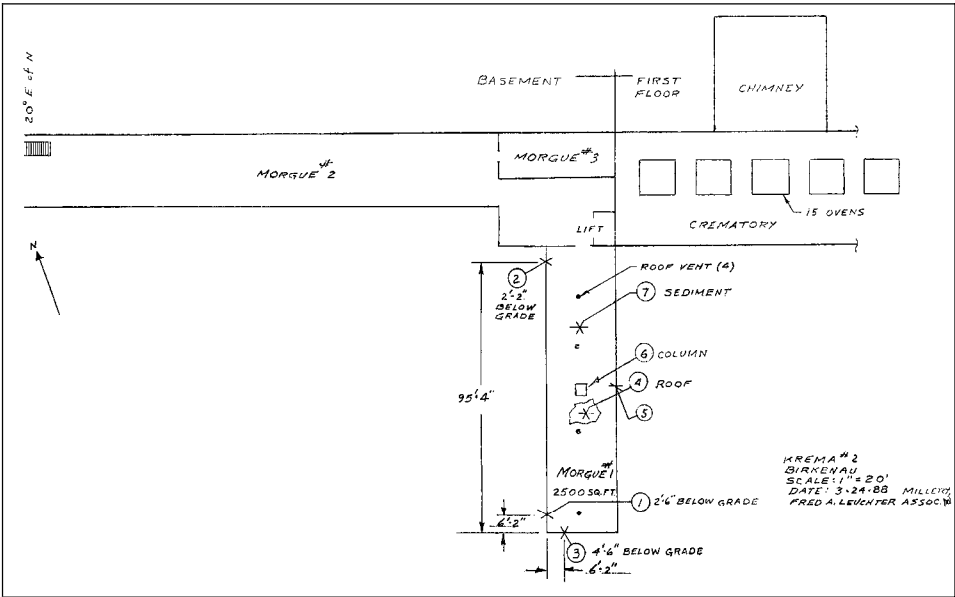
Fig. 13: Floor plan of Krematorium II in Auschwitz Birkenau, drawn by H. Miller, Fred A. Leuchter Associates. Numbers in circles denote locations where wall sample were taken. Note: The "Roof Vent (4)" do not exist; see document on next page.

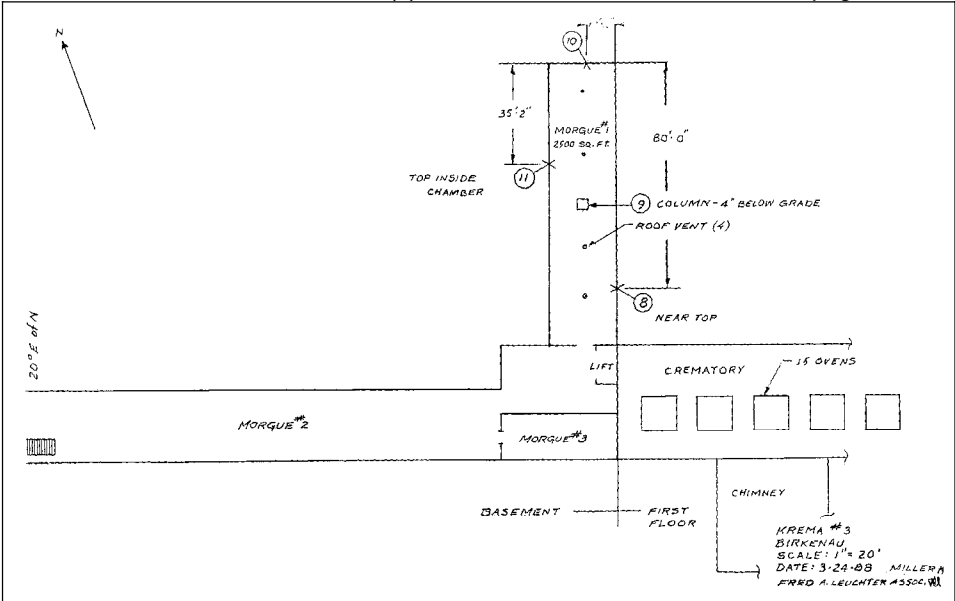
Fig. 14: Floor plan of Krematorium III in Auschwitz Birkenau, drawn by H. Miller, Fred A. Leuchter Associates. Numbers in circles denote locations where wall sample were taken. Note: The "Roof Vent (4)" do not exist; see document on next page.

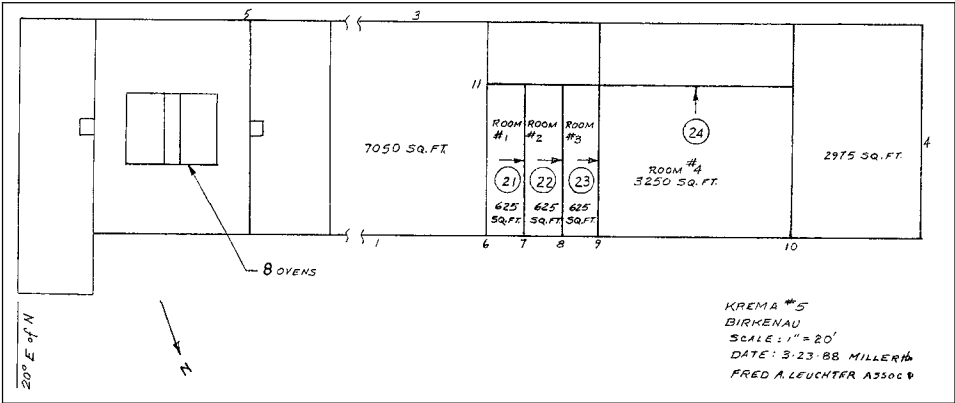
Fig. 17: Floor plan of Krematorium V in Auschwitz Birkenau, drawn by H. Miller, Fred A. Leuchter Associates. Numbers in circles denote locations where wall sample were taken.

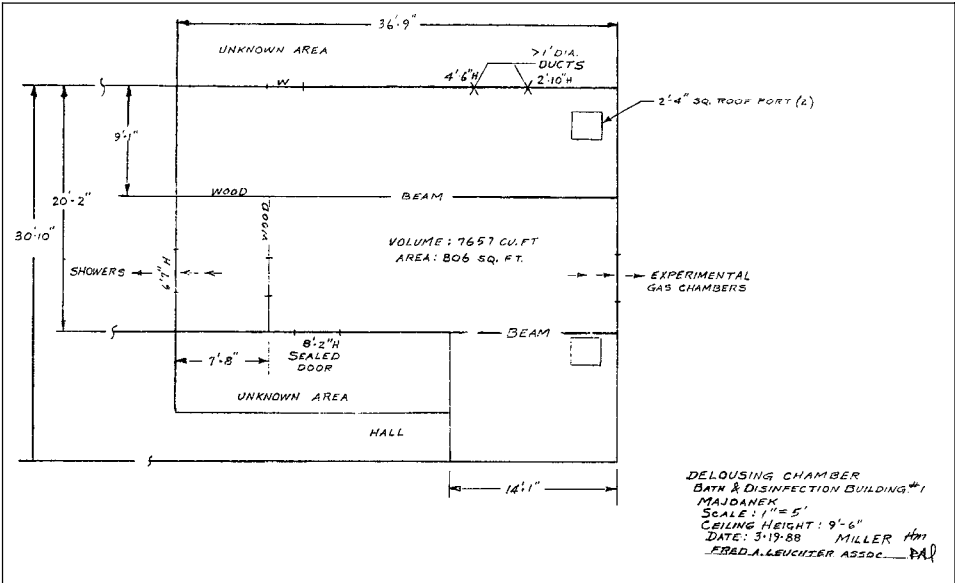
Fig. 18: Floor plan of Bath & Disinfection Building #1 at the Majdanek camp, drawn by H. Miller, Fred A. Leuchter Associates.

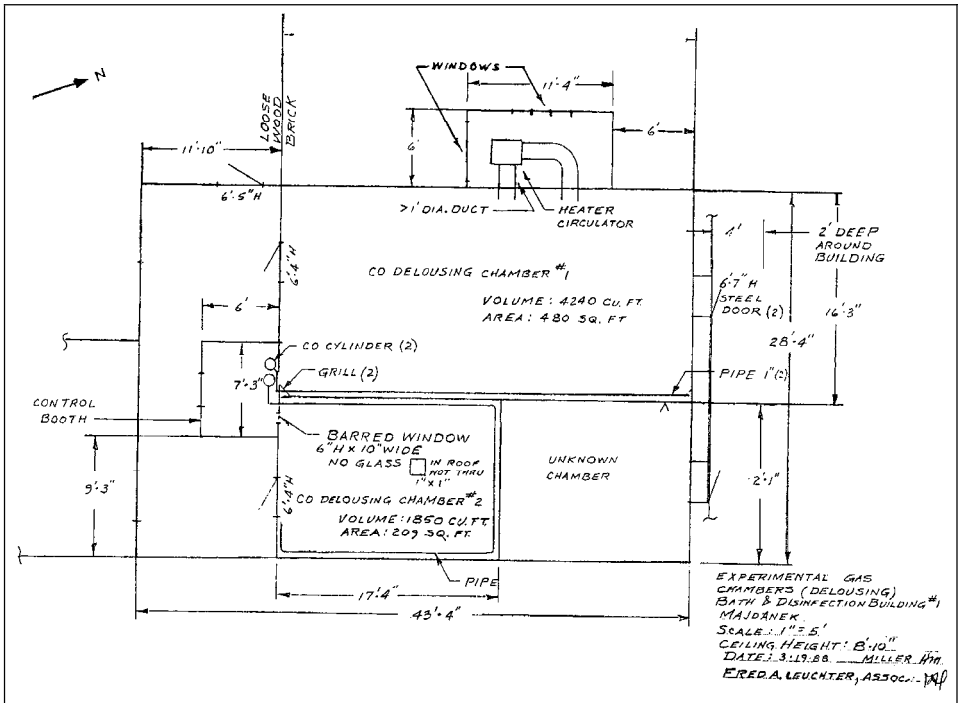
Fig. 19: Floor plan of the delousing wing of Bath & Disinfection Building #1 at the Madjanek camp, drawn by H. Miller, Fred A. Leuchter Associates.

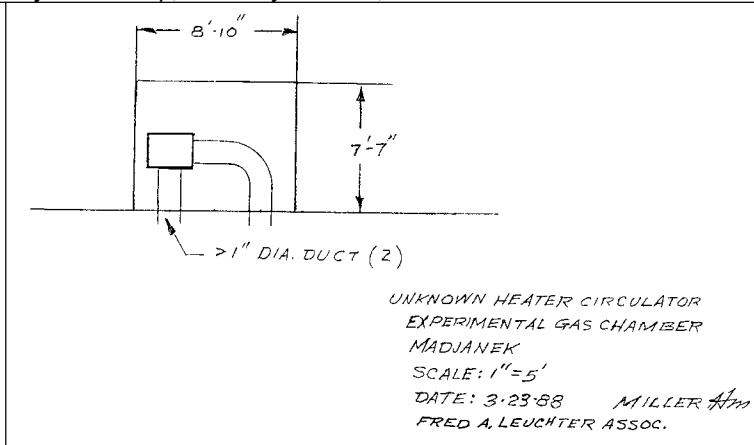
Fig. 20: Sketch of Heater Circulator of delousing chamber in previous document, drawn by H. Miller, Fred A. Leuchter Associates.

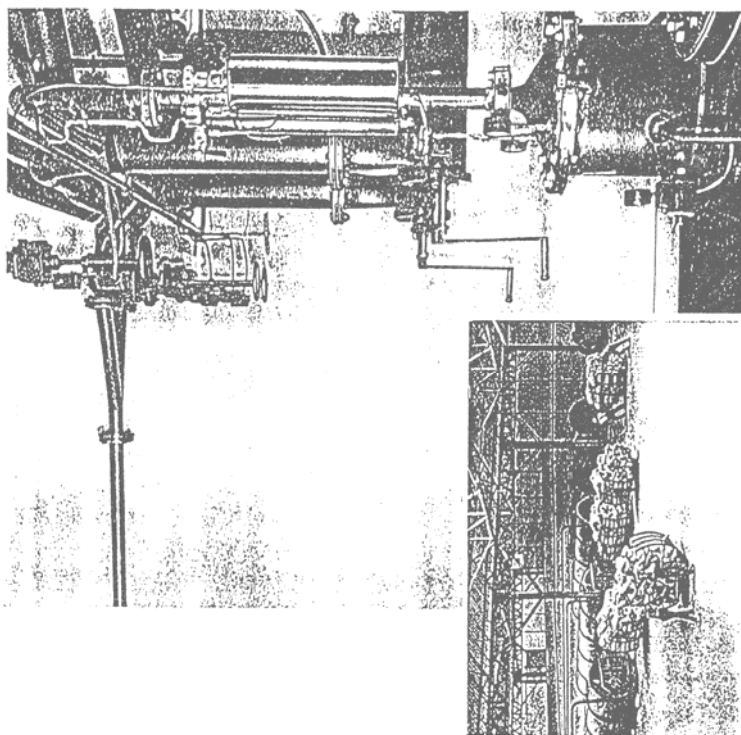
Two ZYKLON vaporizers with special tin openers and a vaporizer for liquid hydrocyanic acid in the generator room of the vacuum fumigation plant, Port of Casablanca.

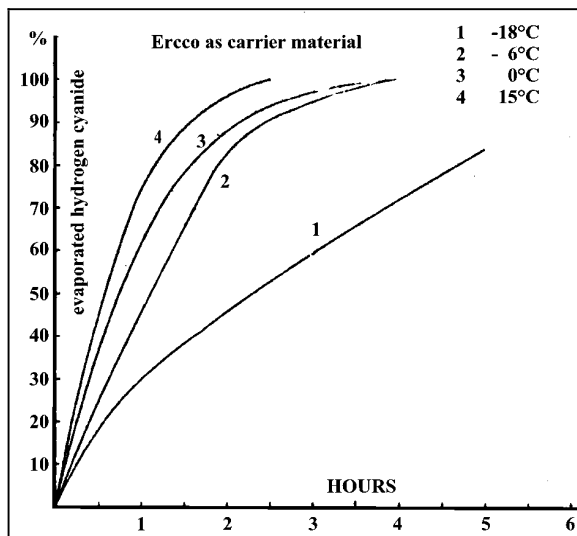
Graph 2: Evaporation rate of hydrogen cyanide from the Ercco carrier material (gypsum with some starch) at various temperatures and fine distribution, according to R. Irmischer/DEGESCH 1942.¹⁶⁵

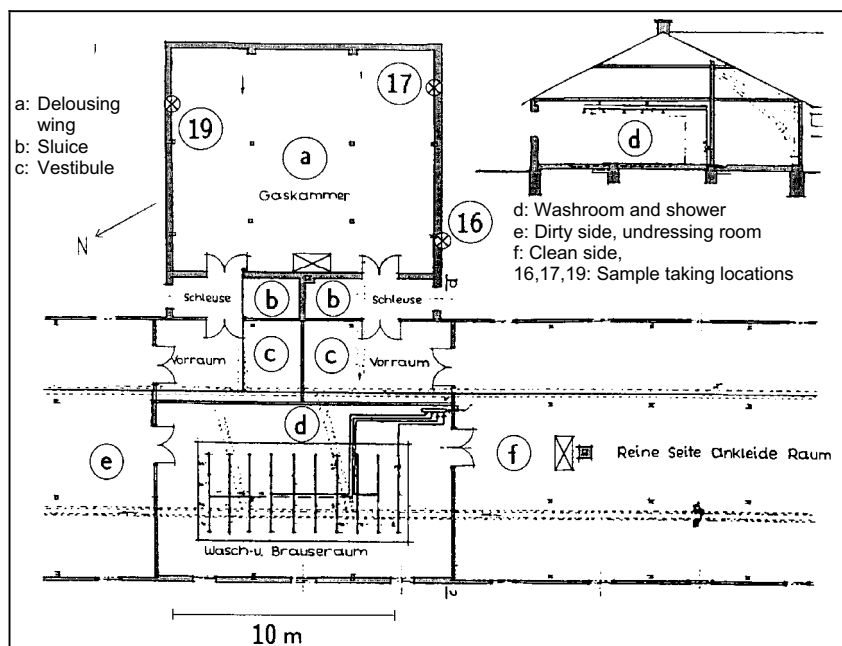
Fig. 23: Ground plan of the HCN disinfestation wing of building 5a before building alterations (mirror image) and BW 5b today. BW 5b sample taking locations for the Rudolf Report drawn in.¹⁷⁴

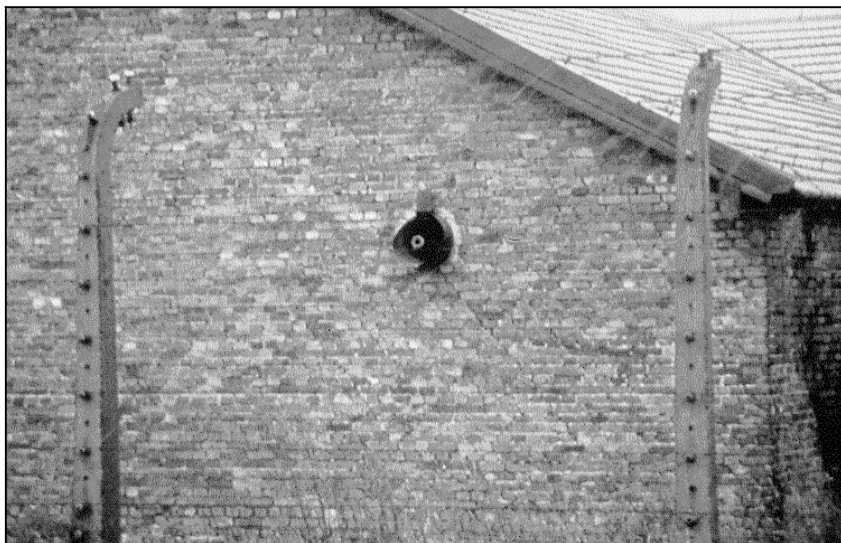
Fig. 24: One of the two ventilation outlets from the disinfestation wing of building BW 5b, without equipment today. The other is located on the same wall slightly to the left. The end of a water pipe put in there after the war is visible.

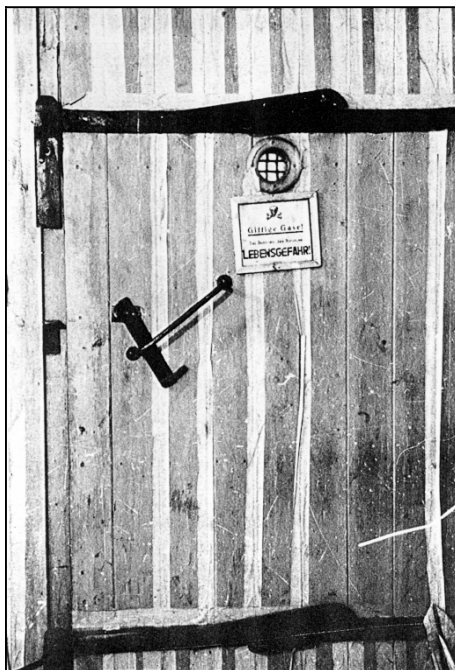
Fig. 25: Wooden disinfestation chamber door at Auschwitz rendered provisionally gas-tight with peephole and metal protection grid. This is what the gas-tight doors for the homicidal ‘gas chambers’ are supposed to have looked like. Note the extremely flimsy lock.¹⁷⁷

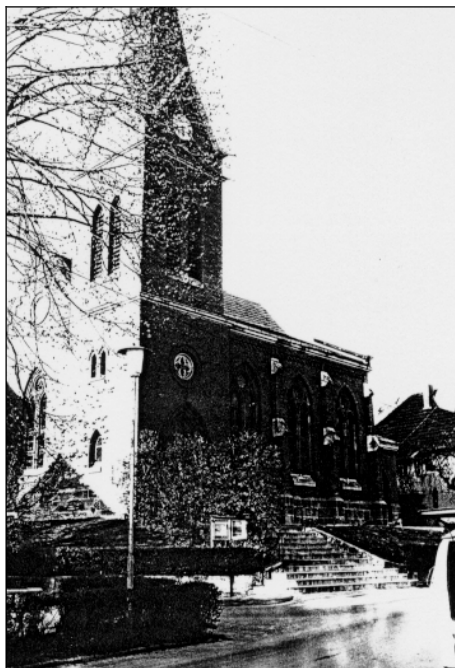
Fig. 36: In August 1976, the Protestant church at D-96484 Meeder-Wiesefeld was fumigated with Zyklon B. Subsequently, blue-colored stains appeared all over the plaster (see Fig. 37).

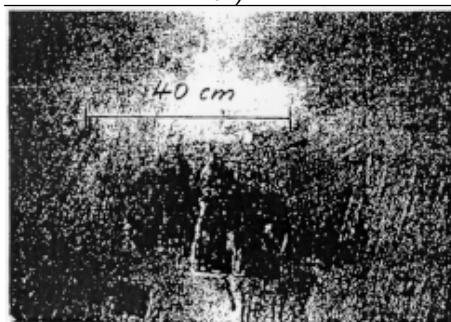
Fig. 37: Inky blue stains on the plaster of a church fumigated with hydrogen cyanide.

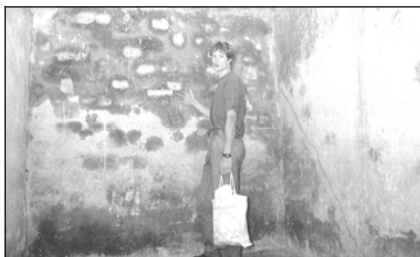
Fig. 38: Blue staining of the interior northwest room in the Zyklon B disinfestation wing of BW 5a in the Birkenau camp. (© Karl Philipp²⁰¹)

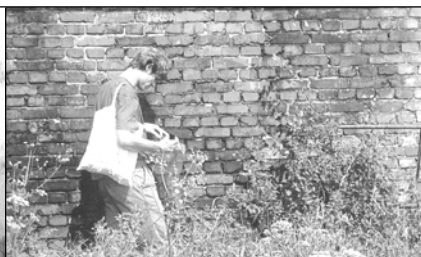
Fig. 39: Blue staining of the exterior southwest wall of the Zyklon B disinfestation wing of BW 5b in the Birkenau camp. (© Karl Philipp²⁰¹)

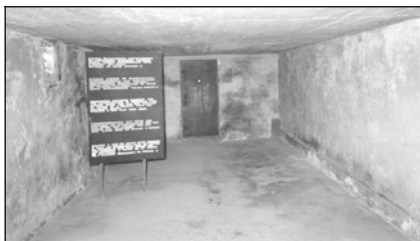
Fig. 40: Blue staining of the Zyklon B disinfestation installation, chamber III, of barrack 41 in Majdanek camp. (© C. Mattogno²⁰²)

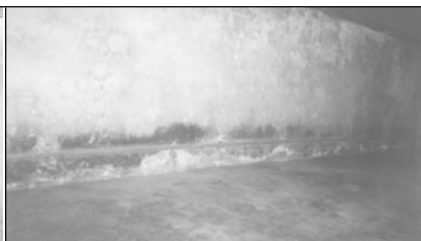
Fig. 41: Blue staining of the Zyklon B disinfestation installation, east wall of chamber III of barrack 41 in Majdanek camp. (© C. Mattogno²⁰²)

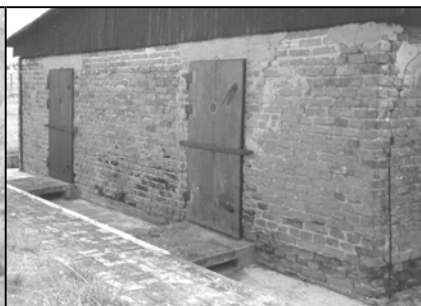
Fig. 43: Blue staining of the Zyklon B disinfestation installation, chambers II and III (exterior wall), of barrack 41 in Majdanek camp. (© Carlo Mattogno²⁰³)

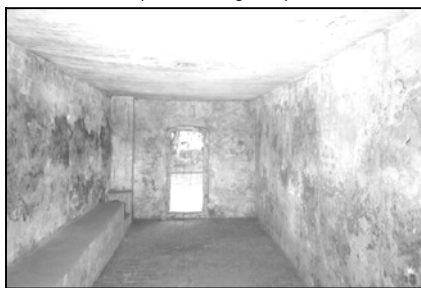
Fig. 44: Blue staining of the Zyklon B disinfestation chamber in Stutthof camp, interior view taken from the south door. (© Carlo Mattogno²⁰⁴)

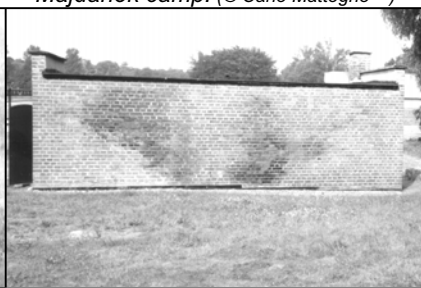
Fig. 45: Blue staining of the Zyklon B disinfestation chamber in Stutthof camp, east side, exterior. (© Carlo Mattogno²⁰⁴)

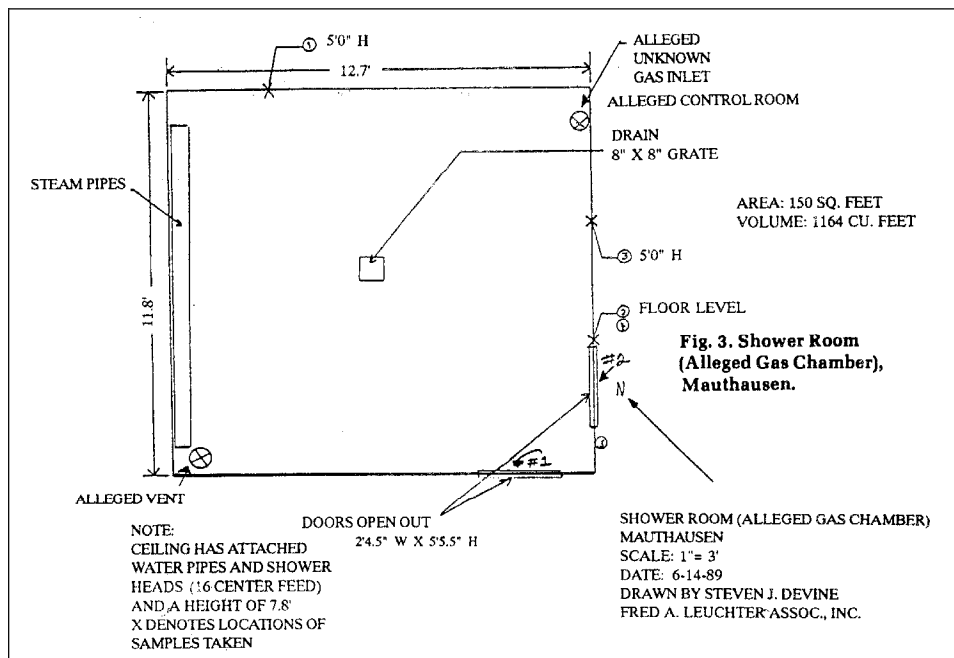
Fig. 49: Floor Plan of the shower (alleged gas chamber) at Mauthausen camp, Austria. Encircled X denote locations of wall samples taken.

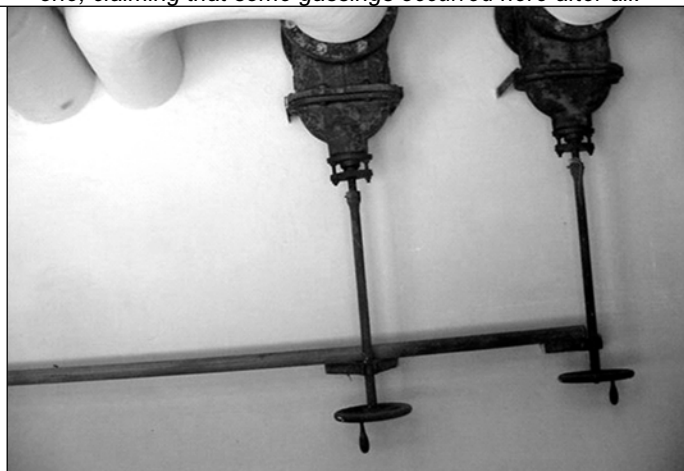
Fig. 51: Heavy insulated hot water (or steam?) pipes in the room behind the alleged gas chamber of Dachau camp, leading into the space above the current room.¹

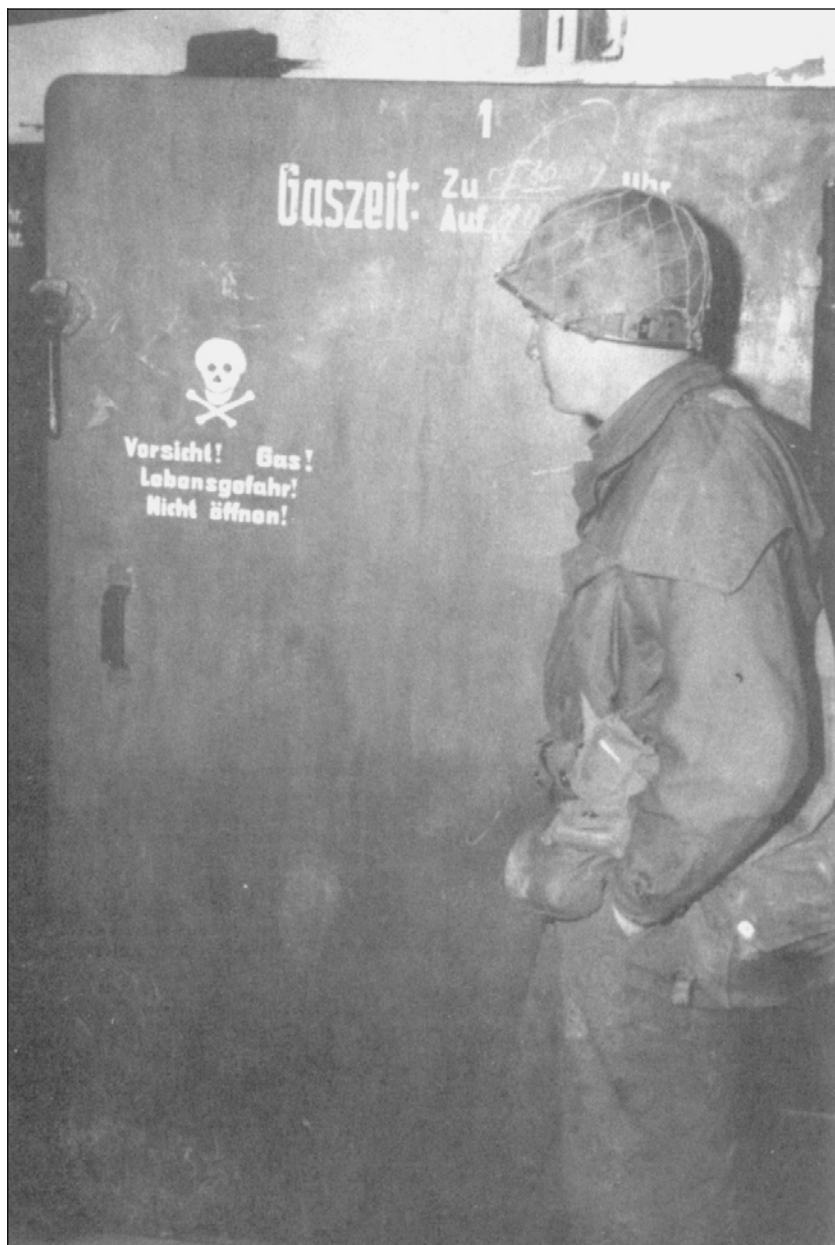
Fig. 52: Door of disinfestation chamber at Dachau. The inscriptions on the door specify that the chamber was last used from 7:30 to 10 in the morning. The warning reads "Caution! Gas! Life danger! Do not open!" The U.S. Army caption for this photograph declares deceptively: "Gas chambers, conveniently located to the crematory, are examined by a soldier of the U.S. Seventh Army. These chambers were used by Nazi guards for killing prisoners of the infamous Dachau concentration camp."²

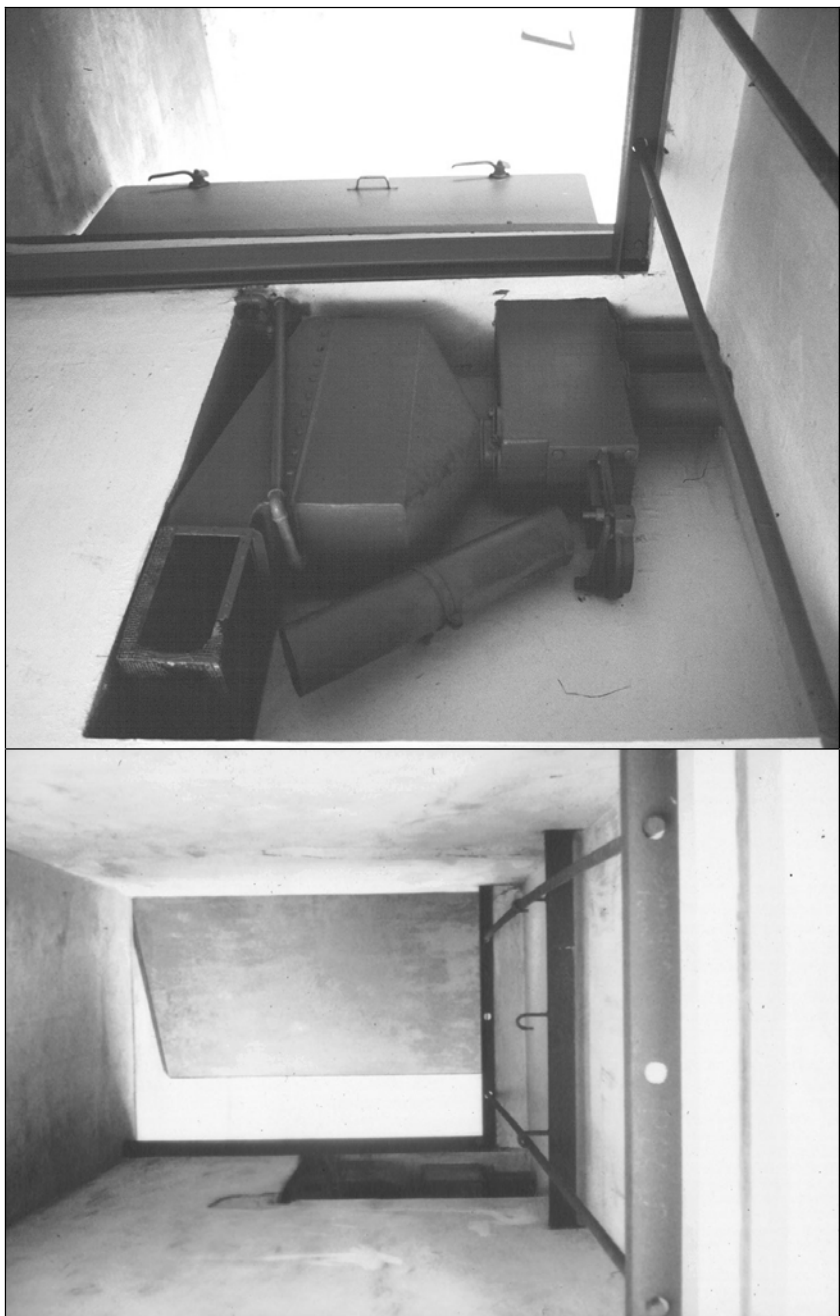
Fig. 57 & 58: Interior of disinfestation chamber at Dachau; left: DEGESCH Kreislaufanlage (circulation device); right: look through the chamber.⁵

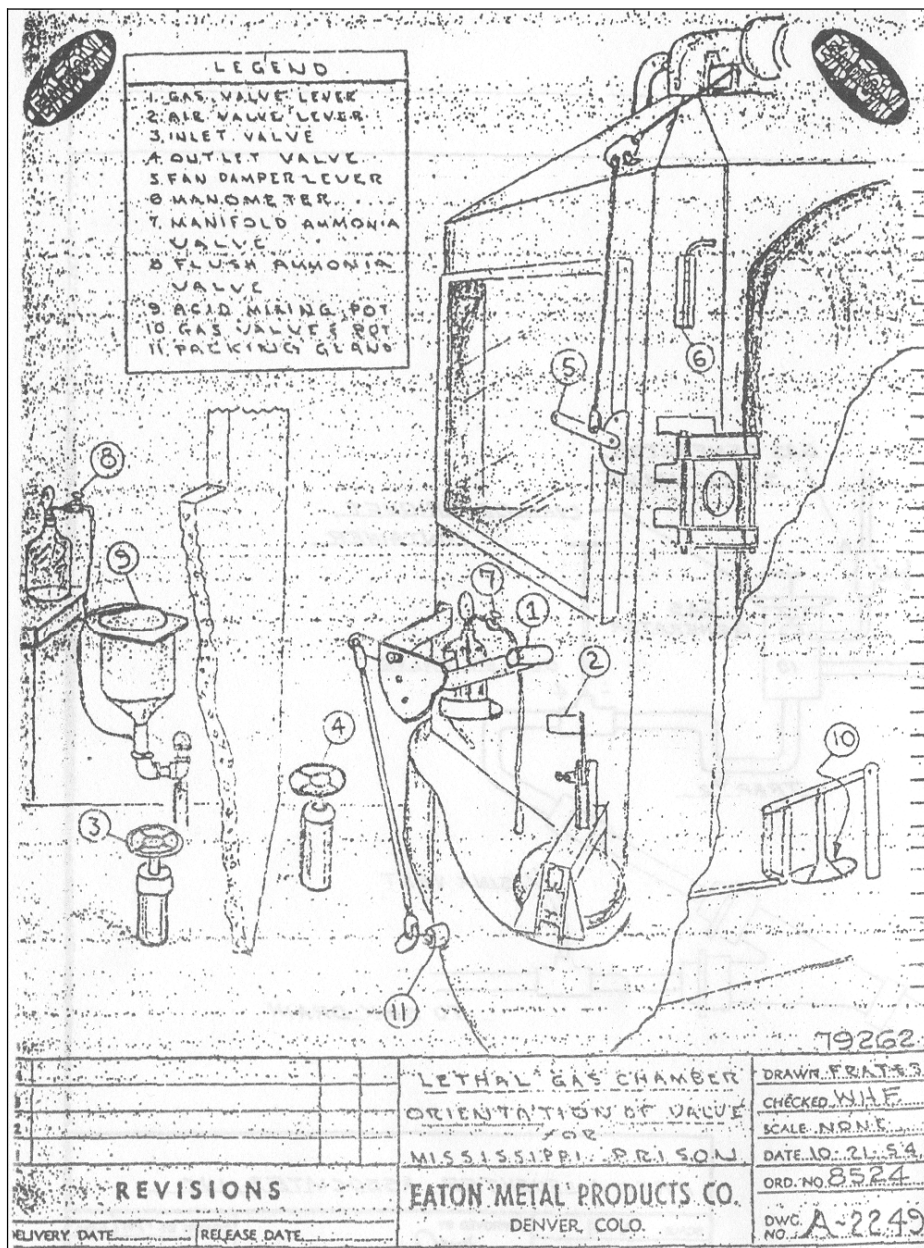
Fig. 66: Eaton Proposal for the lethal gas chamber at the Mississippi State Penitentiary at Parchman, MS, of 1954. Courtesy to the Mississippi Department of Corrections.

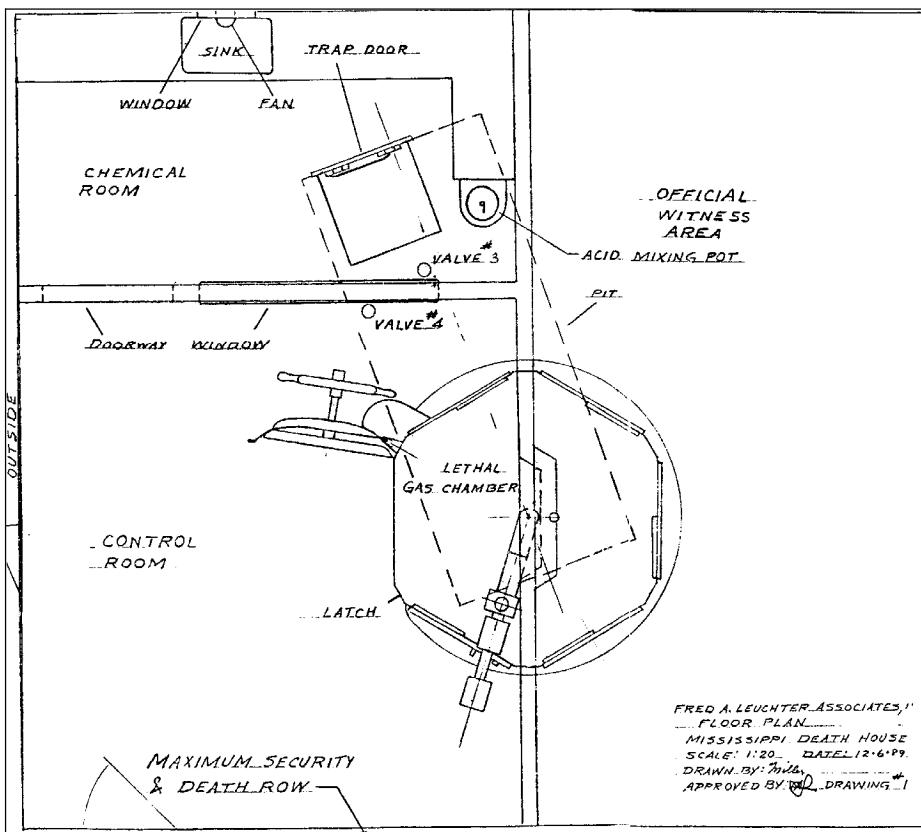
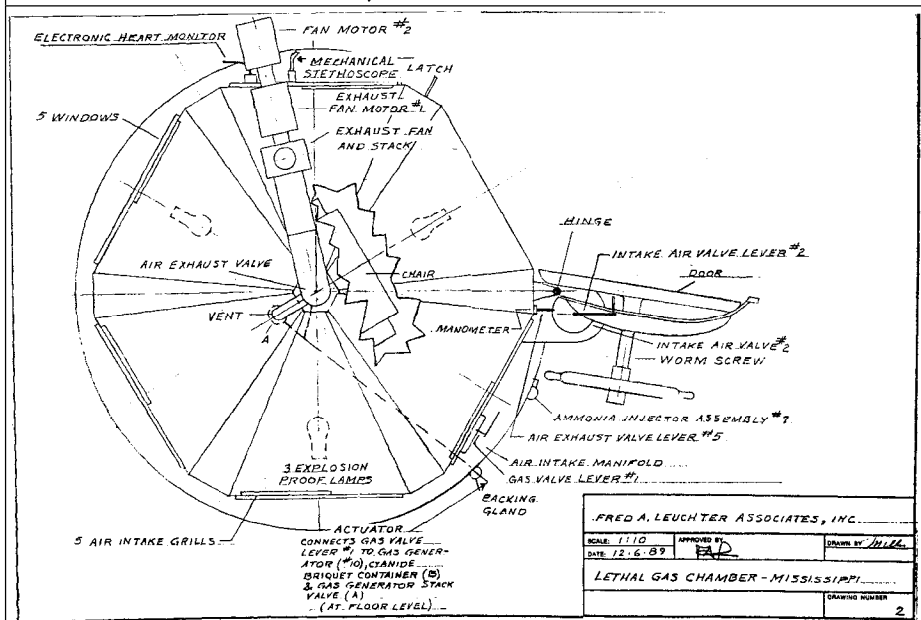
Fig 69 & 70: Technical drawings of the Parchman (MS) execution gas chamber.

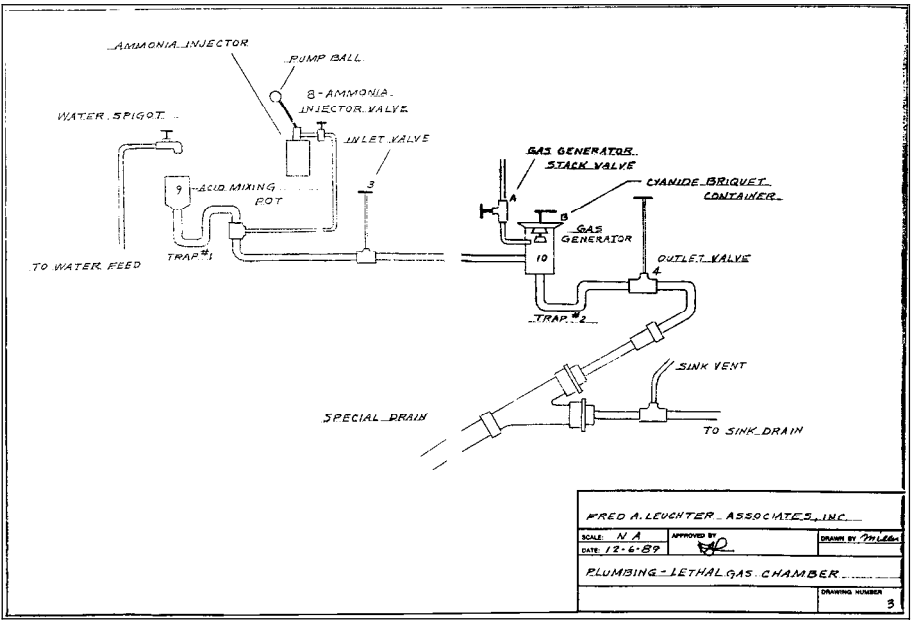
Fig 71: Technical drawing of gas generator of the Parchman (MS) execution gas chamber.

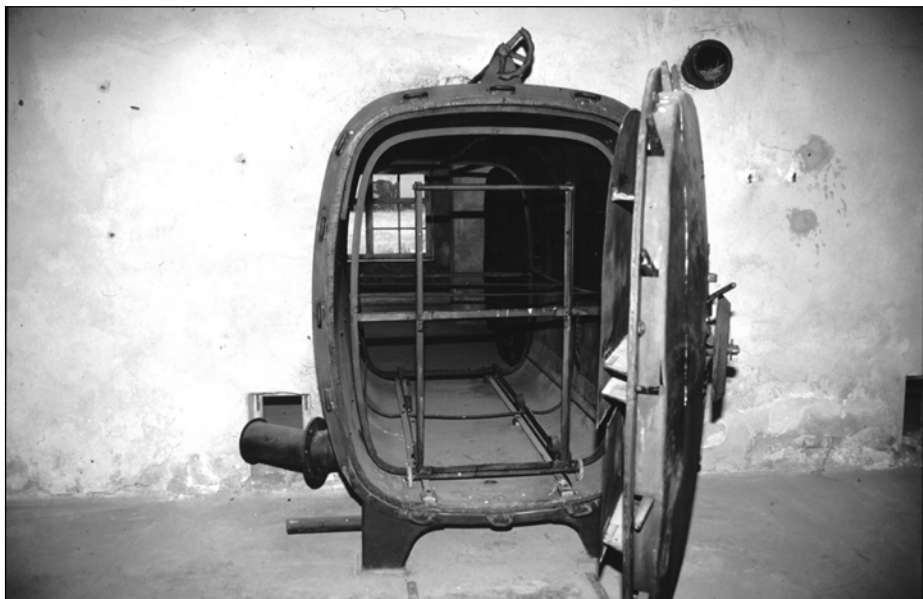
Fig. 78: Hot air disinfestation autoclave in the so-called “Zentralsauna” in Auschwitz Birkenau with similar doors as used for the U.S. execution gas chambers. Although the German camp authorities had the technology required for constructing execution gas chambers, they did not use it. They used this technology to save the lives of their prisoners instead.

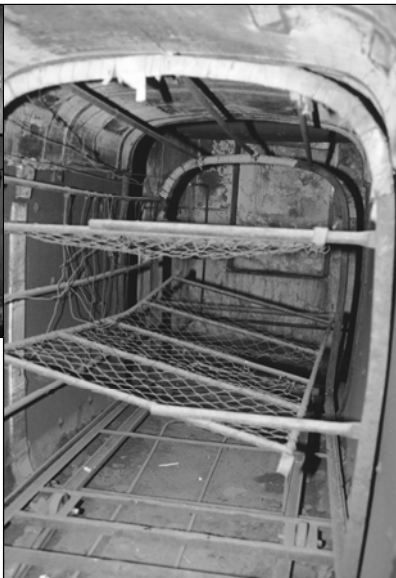
Fig. 80: Inside of the hot air disinfestation autoclave in Mauthausen with rusting cloth racks.

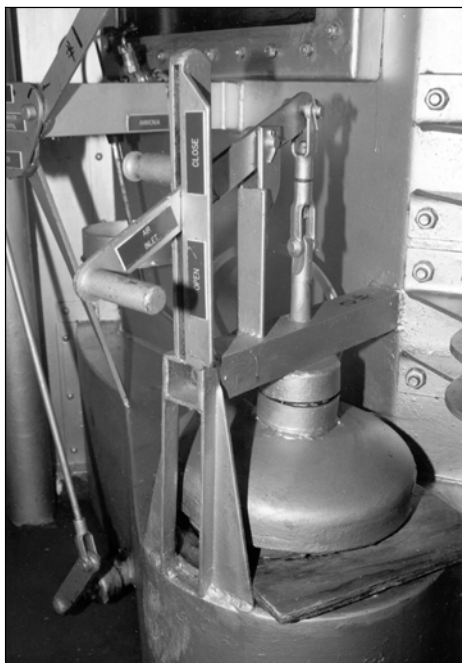
Fig. 84: Closeup of fresh air intake of gas chamber.

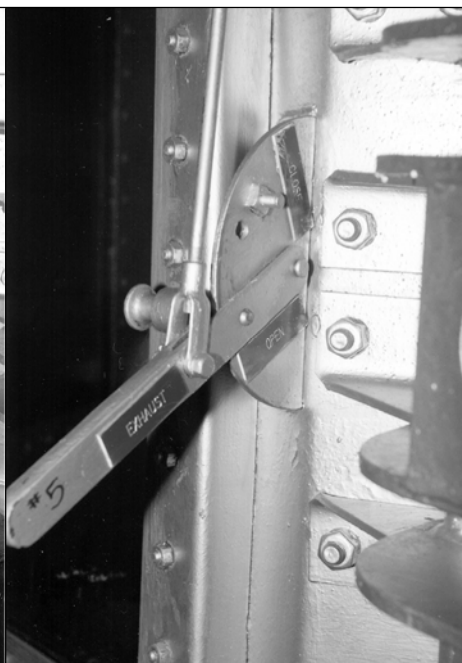
Fig. 85: Closeup of lever used to open and close exhaust stack.

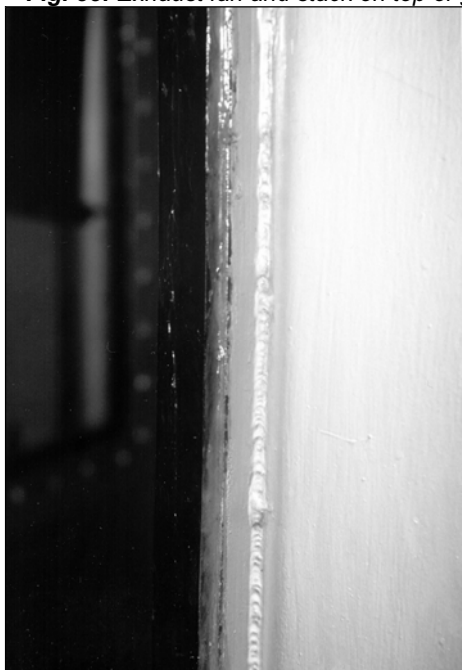
Fig. 90: Closeup of rubber seal around gas chamber door, also covered in vaseline when in use.

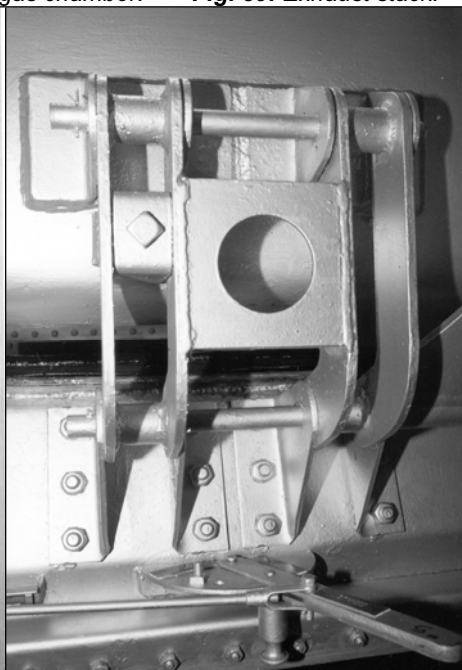
Fig. 91: Closeup of gas chamber door hinge.

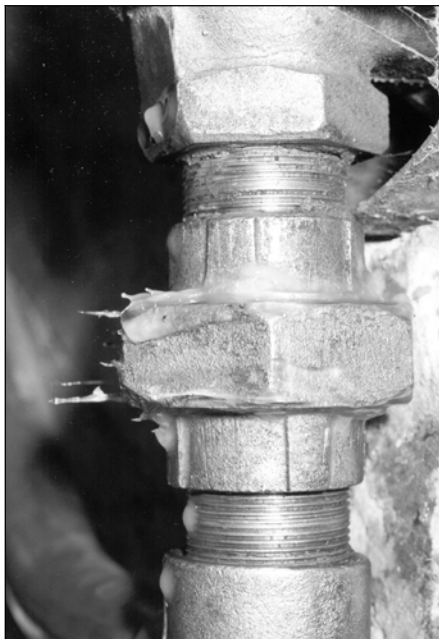
Fig. 92: Closeup of plumbing underneath the gas chamber covered in vaseline to indicate leaks.

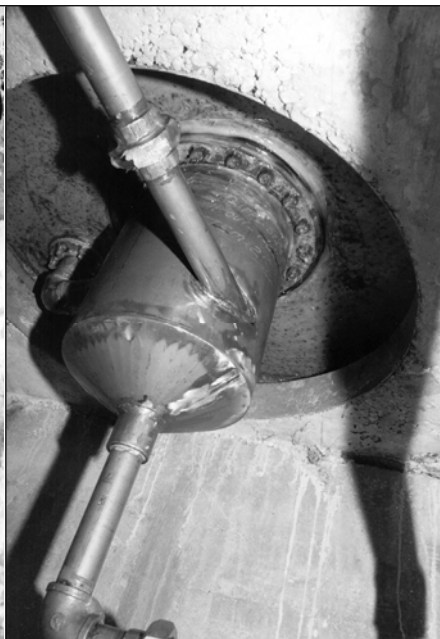
Fig. 93: View of stainless steel plumbing and chemical container directly under seat in gas chamber.

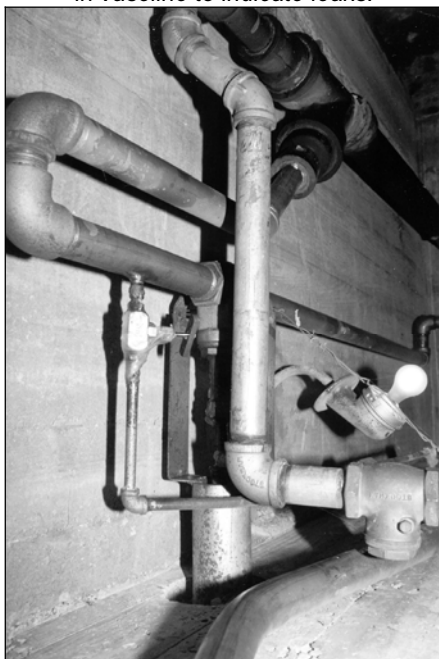
Fig. 94: Portion of plumbing and sewage system connecting chemical room to gas chamber.

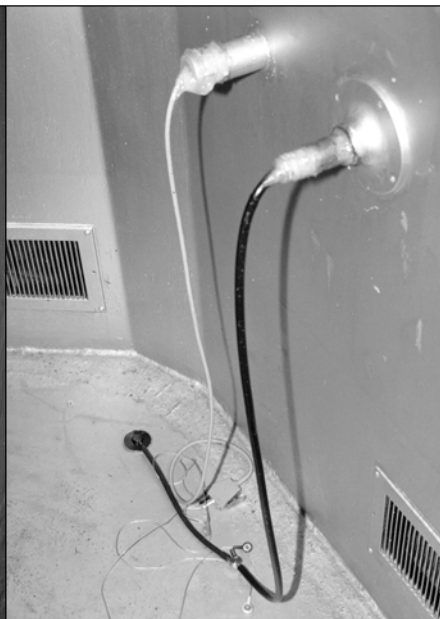
Fig. 97: Inside gas chamber where stethoscope and other body monitoring line enter. They are covered in vaseline to indicate leaks. Fresh air vents on the walls close to the floor.

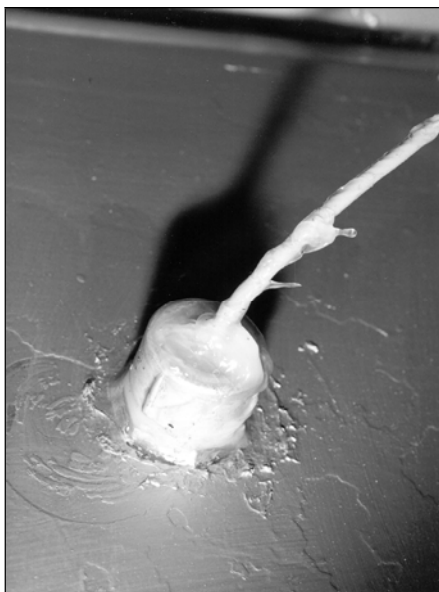
Fig. 98: Closeup of where monitoring line enters chamber also coated in vaseline.
